RAPID NEWS

SUBJECT : Information about the leak-test function on VRV III heat-pump.

Please find on the next pages some explanation about the leak-test function for VRV III, cooling-only model RXQ5 ~ 18P7W1B, and heat-pump model RXYQ5 ~ 54 P7W1B.

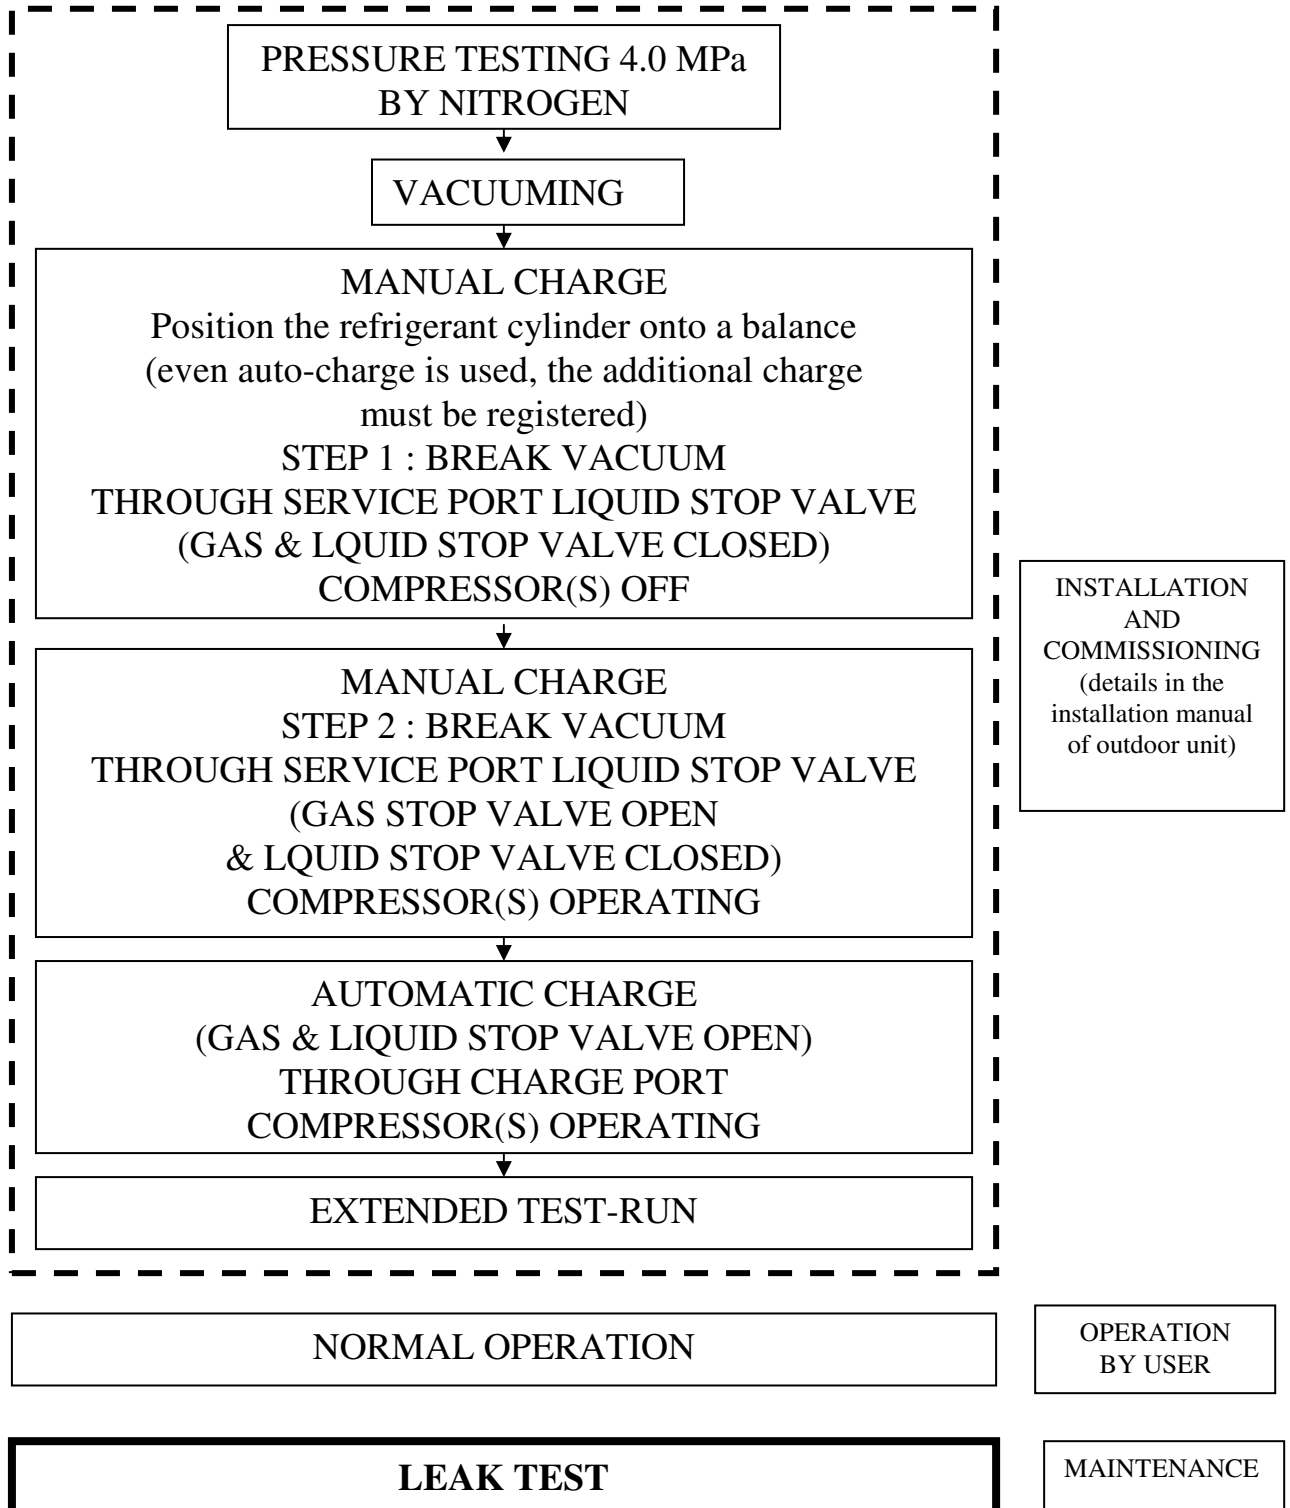
The leak-test function is a feature that can be used during a maintenance.
To have the leak-test function available, following sequence is required during installation.

Details explained in this Rapid News and in next revision of service manual.

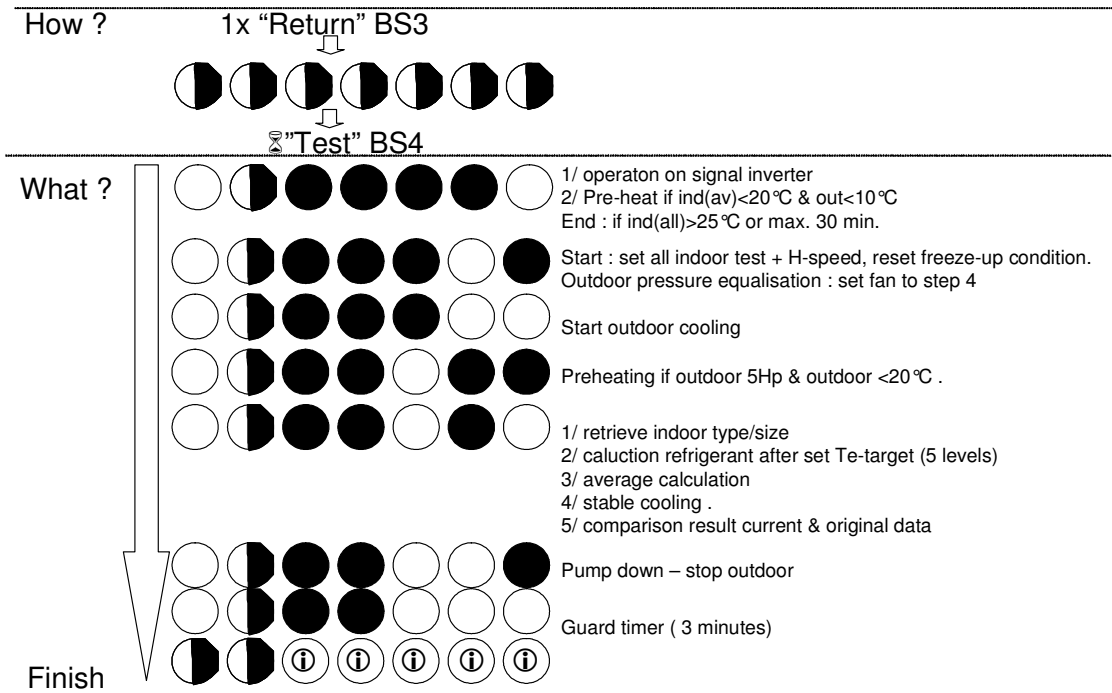
2. Initiation of the leak-test function : After completion of the auto-charge, and the extended test-run , the leak-test function becomes available for later use.
